AGENDA REPORT

Assessment Report for the Pacific View site prepared by Jeff Katz Architecture (JKA).

ENCINITAS PACIFIC VIEW SCHOOL ASSESSMENT REPORT

12.08.21

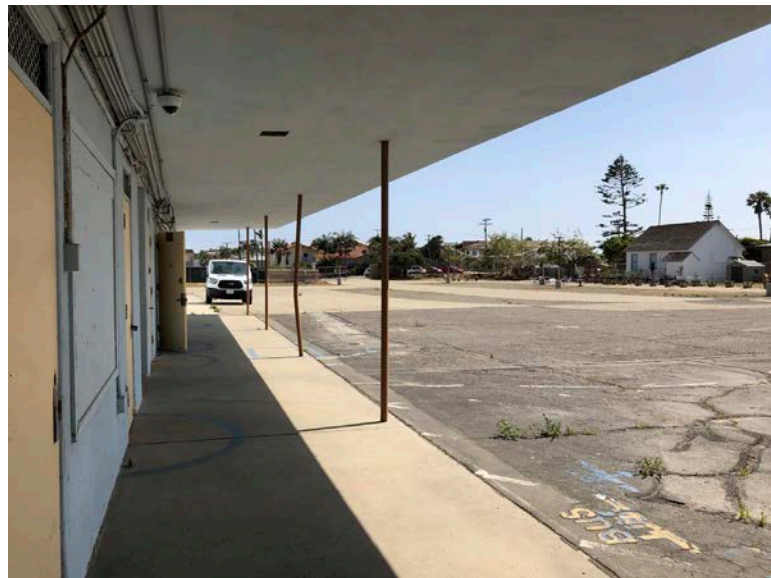
C01

Striping for parking is no longer visible. The parking surface is uneven and damaged. Entrance gate is in working condition. Site lighting is deficient.

Priority 2: Regrade and restripe parking throughout. A civil survey is required to ascertain slopes to area drains. Replace existing site lighting to address code and security issues.

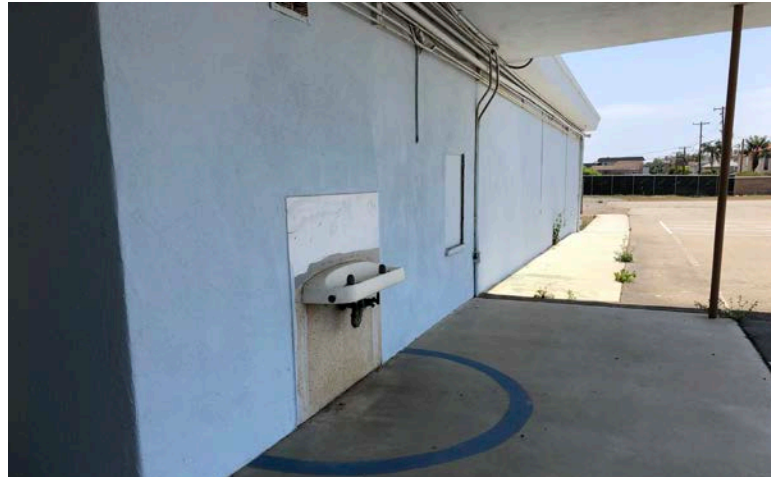
A01

The exterior walls are finished in Stucco. Most exterior walls appear in fair condition. Conduits on the exterior have rusted and are deteriorating.

Priority 1: Repaint the stucco that is in good condition, patch around the openings that will receive new doors/windows. A few walls may need a different finish to highlight architectural features. Exterior conduits for utilities could be resolved by a utility duct bank (trench) running along the perimeter of the building from the NW corner to the SE. Electrical and Mechanical cables and pipes could be routed to access spaces where required.

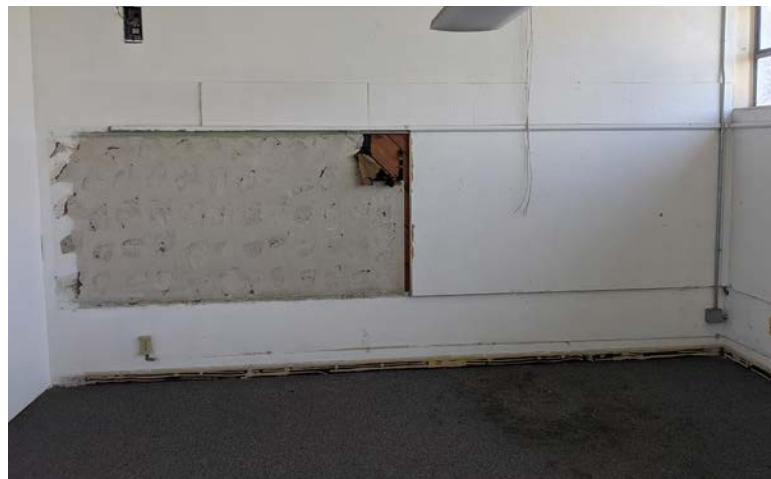
A02

Interior walls are gypsum board/plaster. Walls have significant damage and uneven texture. Existing conduit and receptacles are surface mounted.

Priority 2: Replace gypsum/plaster with new gypsum wall boards and paint. Replace existing conduit, receptacles, switches, and misc. electrical equipment and relocate to inside interior wall framing.

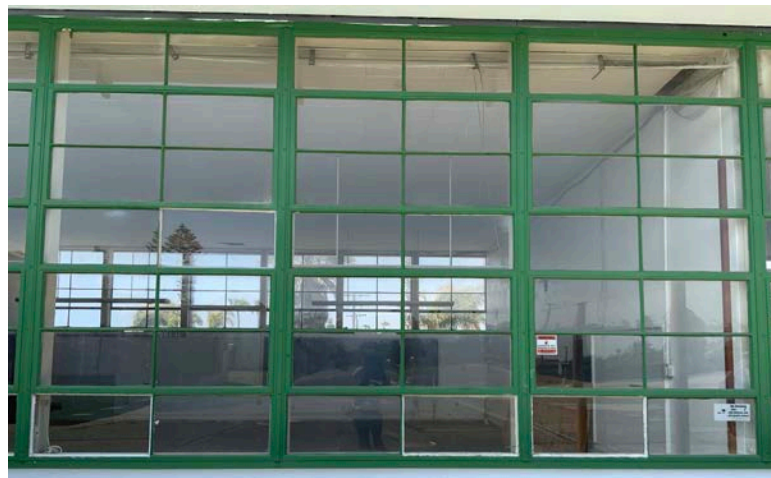
A03

Windows are steel frame with a single pane glass throughout the facility. The steel frame is galvanized and seems to be in good condition, but some opening devices are not functioning. Paint on window frames is lead based.

Priority 2: The single pane should be replaced with an 1/2" thick insulated glass. Some opening devices will need to be replaced for better functionality. Remediate existing lead based paint on steel frames and repaint.

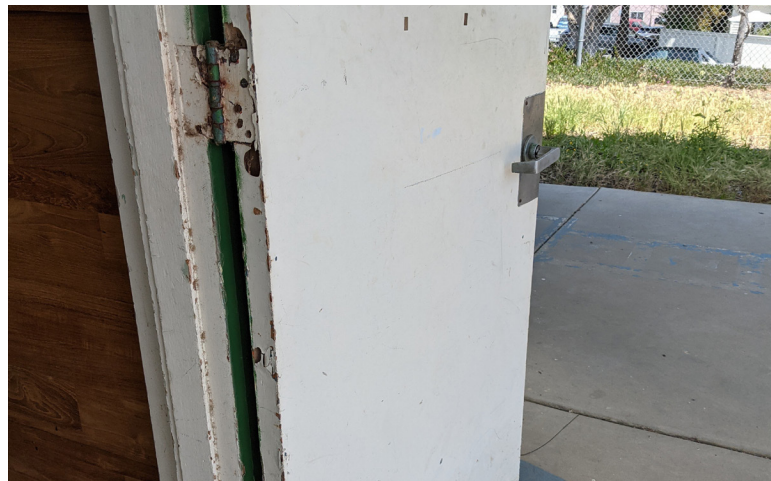
A04

Exterior doors are hollow metal and interior are wood doors. Door frames were wood. All doors, frames, and Hardware were in very poor condition. Doors did not meet ADA requirements for thresholds and operating force.

Priority 1: All doors to be replaced with a HM frame. Exterior doors in HM whilst the interior doors can be wood with new hardware. Doors size & HW should be ADA compliant. Door thresholds will be modified as part of exterior flatwork modifications.

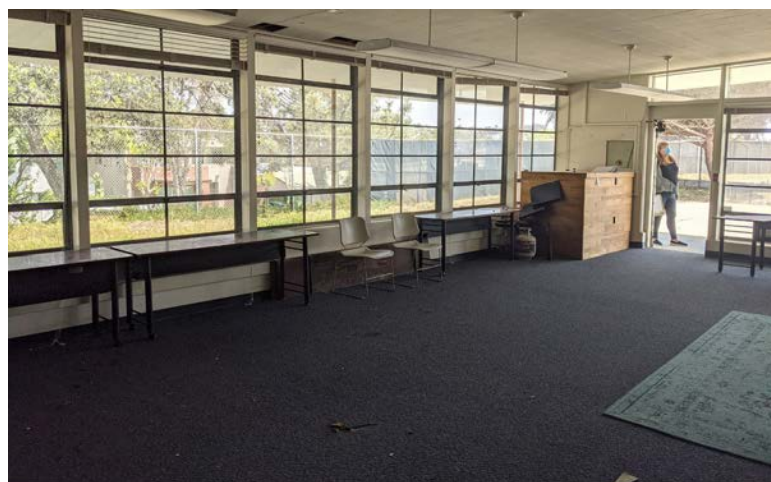
A05

Flooring throughout is a mix of carpet, sheet vinyl & terrazzo. The floor finish in the main functional areas, classroom and offices is carpet, some instances it is carpet over vinyl. Some restrooms had terrazzo, whilst some have sheet vinyl. Storerooms and other ancillary rooms have sheet vinyl or concrete flooring. In general, all flooring is significantly damaged. Floor finishes and transitions do not meet ADA requirements.

Priority 2: All flooring throughout the facility should be removed and replaced. The classrooms should receive a concrete topping which would be polished. Office space floors could be carpet tiles over a self levelling concrete. Restrooms could receive a concrete topping that is polished and sealed or alternately, could be finished with porcelain tiles.

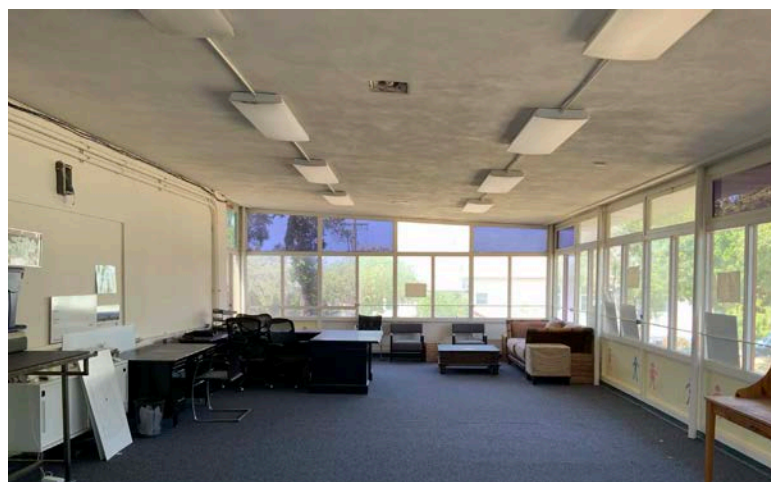
A06

Ceilings are tiles adhered to joists in classrooms, plaster ceiling in enclosed NE office space and other office areas. The ceiling tiles are in poor condition with stains of water intrusion from the roof. The plaster ceiling was intended as an exterior covered walkway and is not appropriate for interior space.

Priority 2: Replace ceiling tiles and plaster ceilings with Gypsum board ceiling and paint smooth. Replace all surface mounted conduit and locate within plenum space detailed elsewhere.

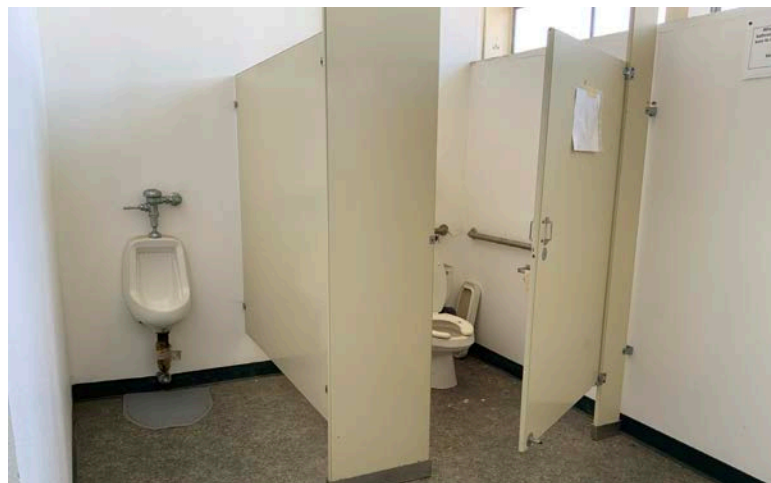
A07

The restrooms are not ADA compliant; the plumbing fixtures are stained, and some are damaged. There are not enough plumbing fixtures to meet current code for E Occupancy.

Priority 1: Demolish restroom fixtures and walls. Revise restroom plan and functional fixture layout.

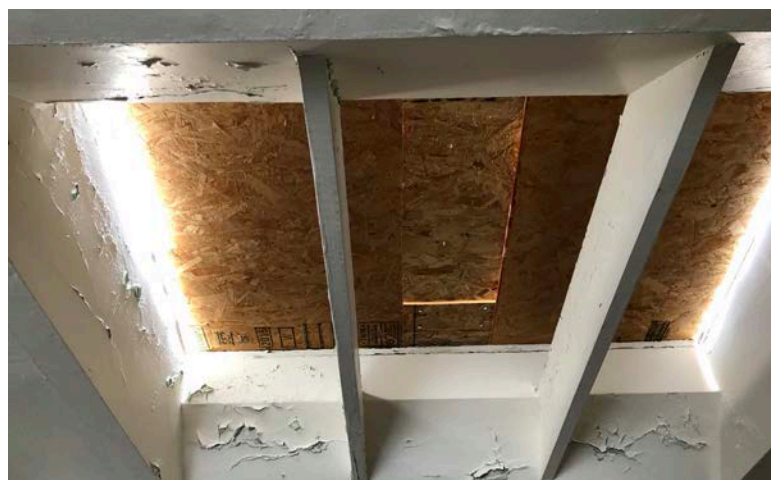
A08

Some water intrusions/ leaks could be observed inside the building ceilings near the skylights.

Priority 1: Close off skylights, install curbs with Solatubes where desired. Recommend roof assembly to consist of 4" polyiso insulation boards, 1/2" coverboard with PVC or TPO roof membrane. All this should be installed over the new 1/2" plywood roof sheathing recommended by structural. The low edge of the roof should have a rain handler (rain dispersal system) to limit soil erosion around the drip line of the roof.

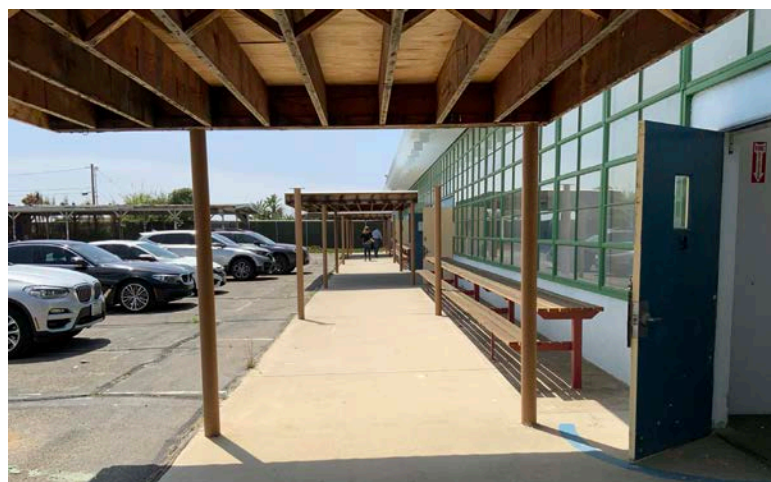
A09

The concrete walkway is in relatively good shape but does not provide an ADA compliant transition to the classroom and office spaces. The wood structure with steel posts and the fixed wood benches have deteriorated and no longer provides any function.

Priority 1: The concrete walkway should be partially demolished along with the fixed wood benches to facilitate the construction of the utility duct bank. The wood structures with steel posts should also be demolished. The walkway should be finished to slope with an exterior grade concrete topping alleviating the ADA issues at the door thresholds and providing a homogeneous finish over the new utility duct bank, whilst capping the demolished steel posts. The partial demolition would also facilitate reinforcing the foundations that will upgrade the structure to current code requirements.

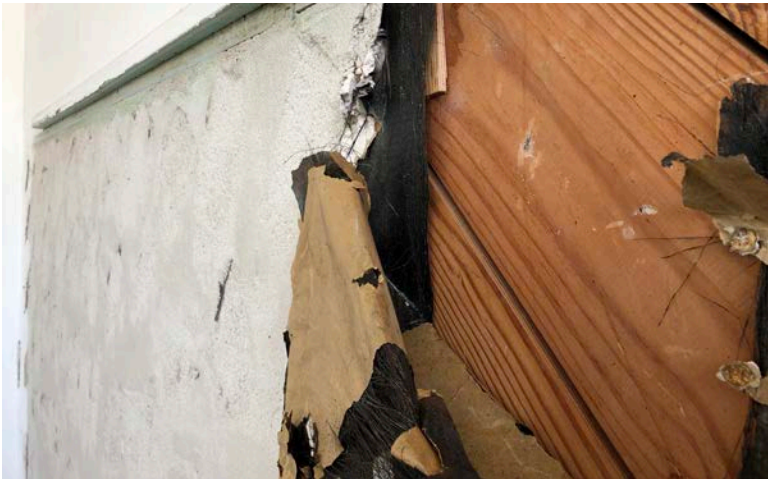
S01

Shear walls and footings do not meet current code requirements.

Priority 1: Reinforce existing shear walls with plywood shear and widen existing wall footing. Add new holdowns to have the structure meet current code requirements. Replace glazing with shear walls and holdowns where required to stabilize the building.

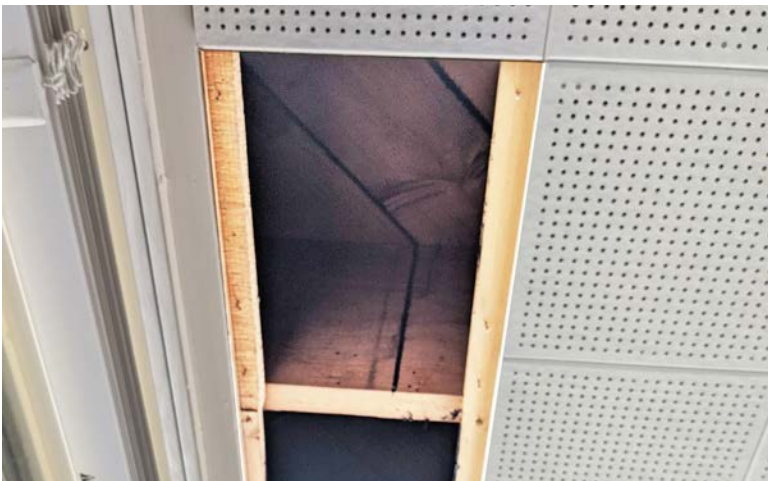
S02

Roof decking is a 1x8 diagonal sheathing.

Priority 1: Reinforce the entire roof diagonal sheathing with a layer of plywood on top of the existing sheathing. Add straps at breaks in the existing roof joist bearing plates.

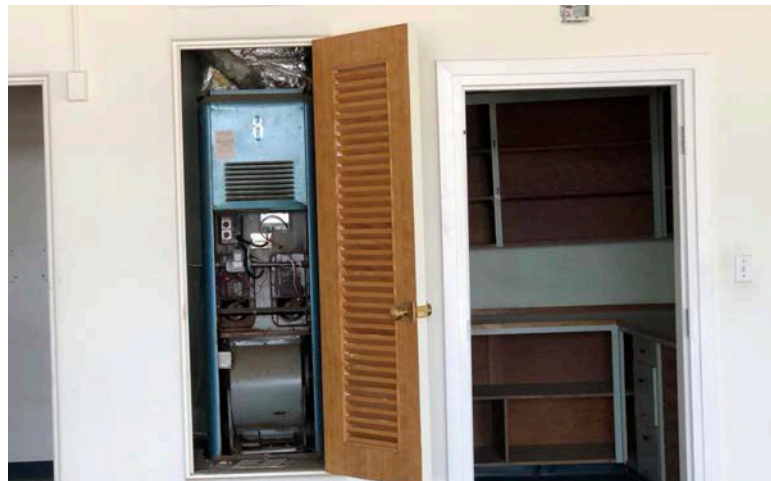
M01

The existing heating systems serving the classrooms and support areas consist of electrical resistance heaters and gas radiant heaters. The majority of the existing heating equipment has either been disconnected, removed and/or appear at the end of their useful life. Cooling doesn't exist within interior spaces.

Priority 1: New exhaust fans shall be provided for restrooms, storage areas, electrical rooms and janitors closet. In classrooms, integrate high efficiency variable refrigerant flow heat recovery heat pumps to condition the occupied areas.

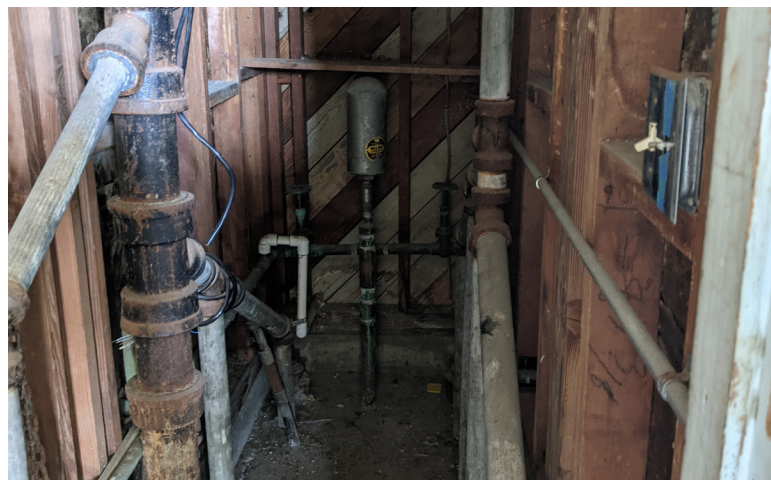
P01

The existing plumbing fixtures are not ADA compliant and do not comply with today's standards for minimum water conservation. Existing water heaters have either been disconnected, removed and/or appear at the end of their useful life. Portions of the plumbing piping have been removed and hot water piping is uninsulated. The gas meter has been removed and gas piping in building is showing signs of severe degradation. The waste & vent piping also shown visual signs of exterior degradation.

Priority 1: New fixtures shall be provided which shall meet current ADA requirements and current low-flow water conservation requirements. New accessible accommodation fixtures shall be placed in locations which are in full compliance with current ADA accessibility requirements. Re-positions and adjustments of piping in the floor and wall shall be necessary as required to accommodate connection to new fixture locations. Piping shall be replaced and/or reconfigured to accommodate new fixture installations.

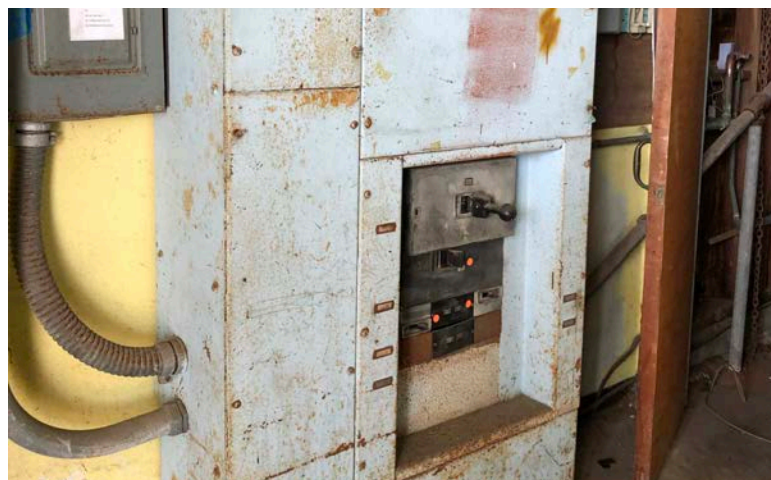
E01

The existing electrical service from SDG&E is insufficient for this facility, is not code compliant and is past it's useful life.

Priority 1: A new 600A 208V 3PH SDG&E meter board (exterior) to be installed (presumably) at the NW corner. The nearest transformer is on the W. St. Routing of conduit to be confirmed with SDG&E.

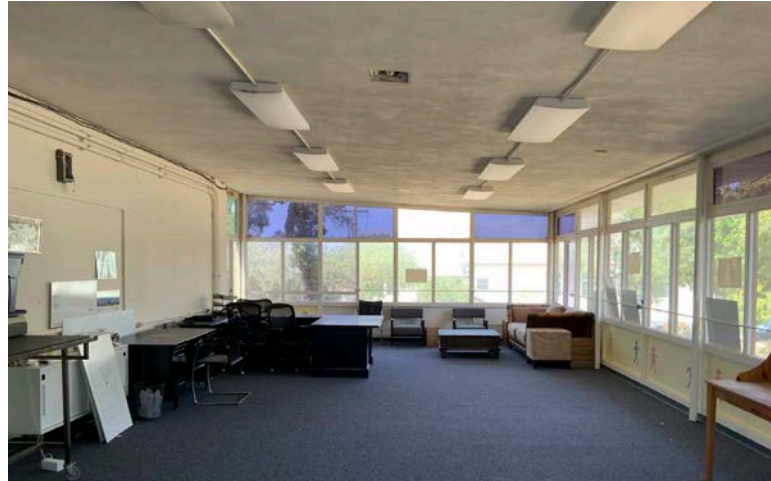
E02

Existing light fixtures throughout are damaged and do not meet current code requirements.

Priority 1: Replace existing fixtures with LED pendant lights, surface mounted fixtures, and recessed can lights.
