AGENDA REPORT

Assessment Report for the Pacific View site prepared by Jeff Katz Architecture (JKA).

ENCINITAS PACIFIC VIEW SCHOOL ASSESSMENT REPORT

12.08.21

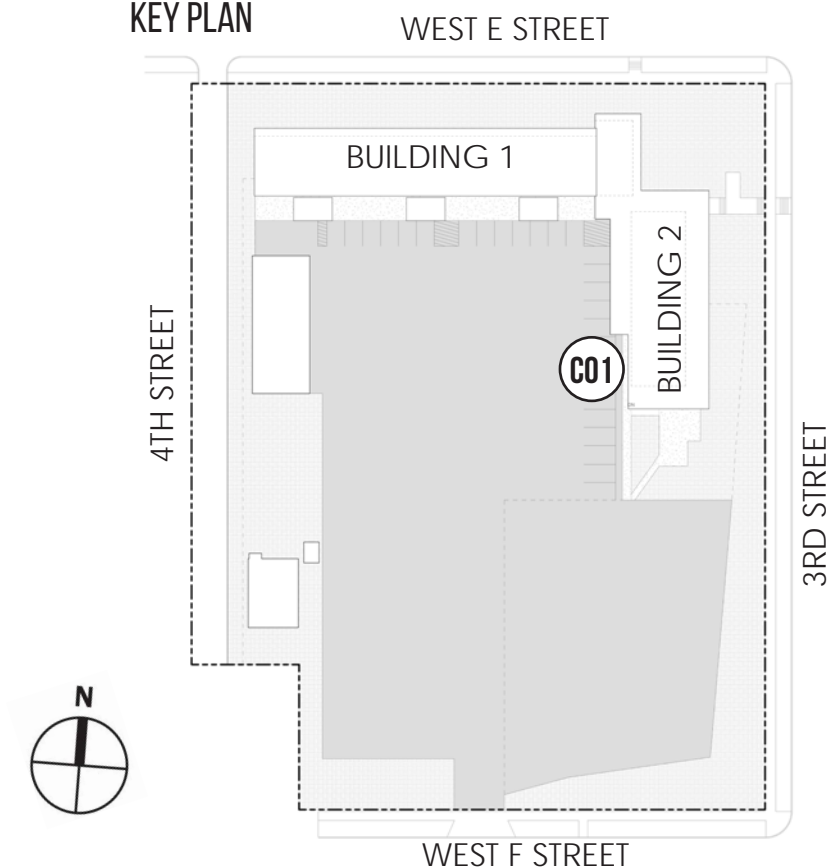
Striping for parking is no longer visible. The parking surface is uneven and damaged. Entrance gate is in working condition. Site lighting is deficient.

Priority 2: Regrade and restripe parking throughout. A civil survey is required to ascertain slopes to area drains. Replace existing site lighting to address code and security issues.

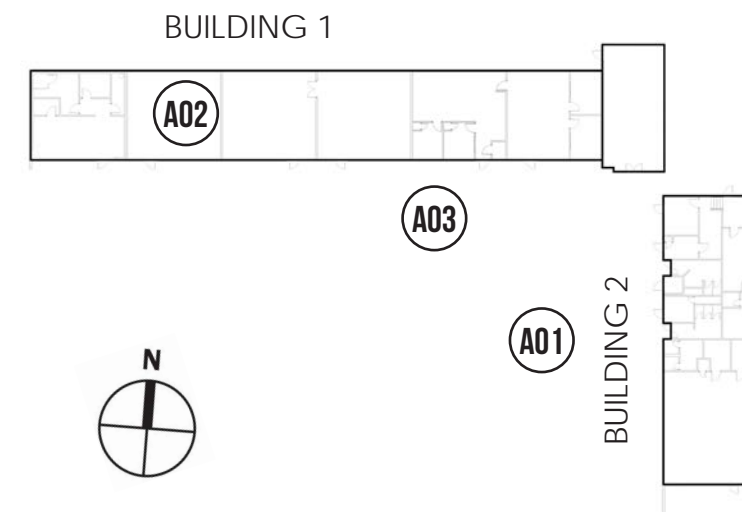
The exterior walls are finished in Stucco. Most exterior walls appear in fair condition. Conduits on the exterior have rusted and are deteriorating.

Interior walls are gypsum board/plaster. Walls have significant damage and uneven texture. Existing conduit and receptacles are surface mounted.

Windows are steel frame with a single pane glass throughout the facility. The steel frame is galvanized and seems to be in good condition, but some opening devices are not functioning. Paint on window frames is lead based.

Priority 1: Repaint the stucco that is in good condition, patch around the openings that will receive new doors/windows. A few walls may need a different finish to highlight architectural features. Exterior conduits for utilities could be resolved by a utility duct bank (trench) running along the perimeter of the building from the NW corner to the SE. Electrical and Mechanical cables and pipes could be routed to access spaces where required.

Priority 2: Replace gypsum/plaster with new gypsum wall boards and paint. Replace existing conduit, receptacles, switches, and misc. electrical equipment and relocate to inside interior wall framing.

Priority 2: The single pane should be replaced with an 1/2" thick insulated glass. Some opening devices will need to be replaced for better functionality. Remediate existing lead based paint on steel frames and repaint.

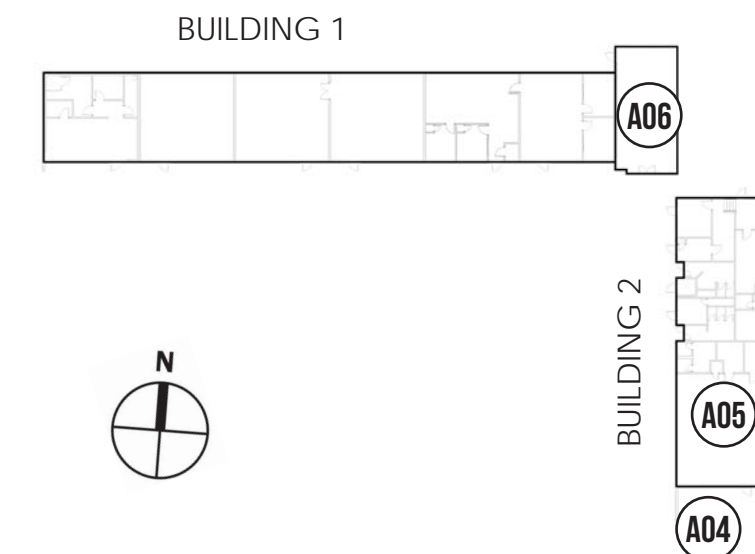
Exterior doors are hollow metal and interior are wood doors. Door frames were wood. All doors, frames, and Hardware were in very poor condition. Doors did not meet ADA requirements for thresholds and operating force.

Flooring throughout is a mix of carpet, sheet vinyl & terrazzo. The floor finish in the main functional areas, classroom and offices is carpet, some instances it is carpet over vinyl. Some restrooms had terrazzo, whilst some have sheet vinyl. Storerooms and other ancillary rooms have sheet vinyl or concrete flooring. In general, all flooring is significantly damaged. Floor finishes and transitions do not meet ADA requirements.

Ceilings are tiles adhered to joists in classrooms, plaster ceiling in enclosed NE office space and other office areas. The ceiling tiles are in poor condition with stains of water intrusion from the roof. The plaster ceiling was intended as an exterior covered walkway and is not appropriate for interior space.

Priority 1: All doors to be replaced with a HM frame. Exterior doors in HM whilst the interior doors can be wood with new hardware. Doors size & HW should be ADA compliant. Door thresholds will be modified as part of exterior flatwork modifications.

Priority 2: All flooring throughout the facility should be removed and replaced. The classrooms should receive a concrete topping which would be polished. Office space floors could be carpet tiles over a self levelling concrete. Restrooms could receive a concrete topping that is polished and sealed or alternately, could be finished with porcelain tiles.

Priority 2: Replace ceiling tiles and plaster ceilings with Gypsum board ceiling and paint smooth. Replace all surface mounted conduit and locate within plenum space detailed elsewhere.

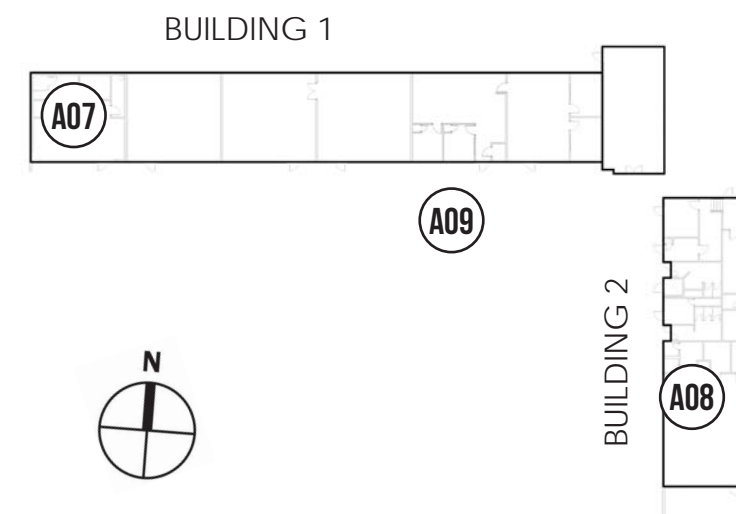
The restrooms are not ADA compliant; the plumbing fixtures are stained, and some are damaged. There are not enough plumbing fixtures to meet current code for E Occupancy.

Priority 1: The concrete walkway should be partially demolished along with the fixed wood benches to facilitate the construction of the utility duct bank. The wood structures with steel posts should also be demolished. The walkway should be finished to slope with an exterior grade concrete topping alleviating the ADA issues at the door thresholds and providing a homogeneous finish over the new utility duct bank, whilst capping the demolished steel posts. The partial demolition would also facilitate reinforcing the foundations that will upgrade the structure to current code requirements.
